SIGNIFICANT CHANGES TO THE

FLORIDA BUILDING CODE: BUILDING

7TH EDITION (2020)

110.3 Required Inspections

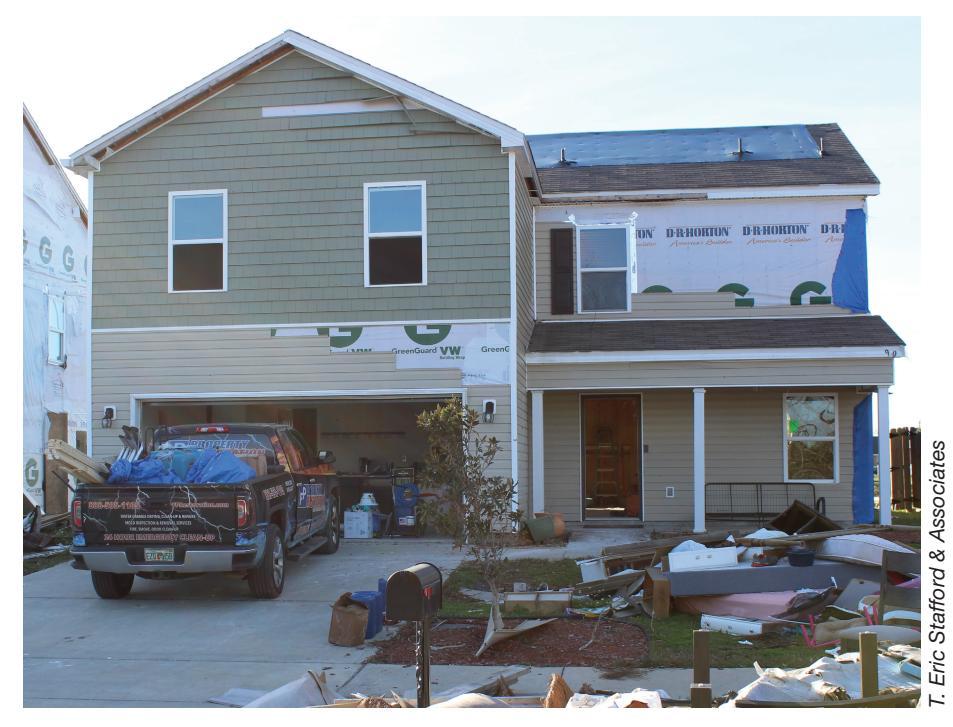
Failure of vinyl siding and soffit due to Hurricane Michael

However, the failure of soffits due to wind loads continues to be prevalent in Florida. Field investigations following Hurricanes Irma and Michael in Florida indicated widespread failure of soffits throughout the impact area. The failure of vinyl soffit panels in Hurricanes Irma and Michael was particularly prevalent.

The failure of exterior wall coverings also contributes to water intrusion. Field investigations indicate that the failure of vinyl siding was widespread in Hurricanes Irma and Michael, but other types of siding, such as fiber-cement siding, were also vulnerable.

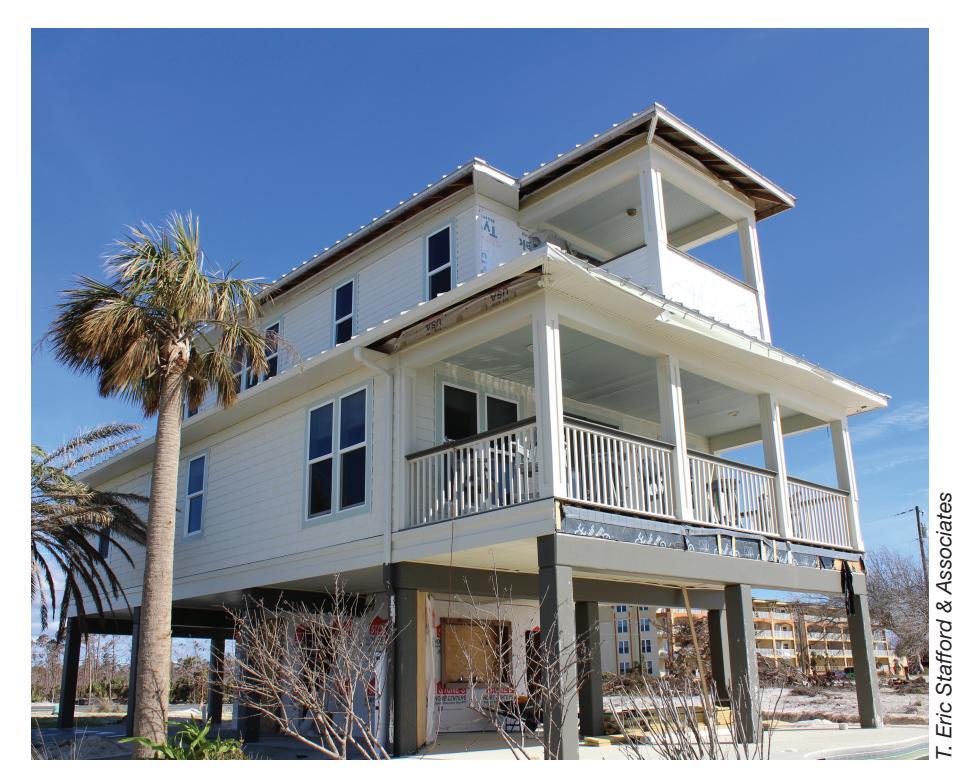
Failure of soffit due to Hurricane Michael

CONCLUSION FL-15: Improper installation of soffits led to inadequate resistance to wind pressures. Widespread loss of soffits was observed in residential construction, and wind-driven rain infiltrated many areas where soffits were displaced or lost.

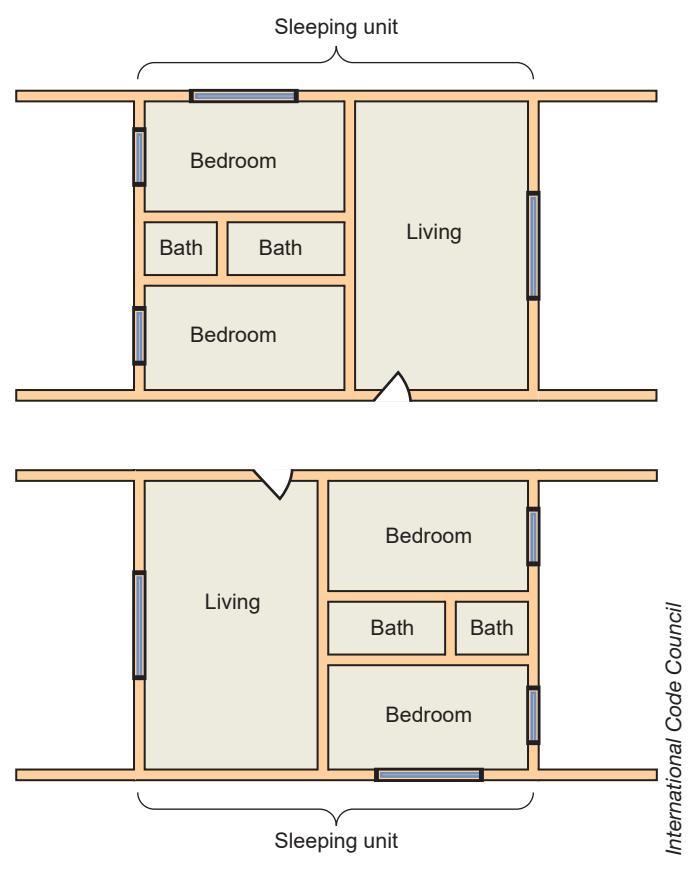
Dormitory suites

CHANGE SIGNIFICANCE: The single required characteristic of a sleeping unit is that it is used as the primary location for sleeping purposes. Guestrooms of Group R-1 hotels and motels are typically considered sleeping units. Sleeping units are also commonly found in congregate living facilities, such as dormitories, sorority houses and fraternity houses, and are regulated as Group R-2 occupancies. Several of the varied Group I occupancies also contain resident or patient sleeping units. Of major importance, sleeping units are required by Section 420 to be separated from
